LANDSLIDES AND RELATED FEATURES

OF THE PETROS, TENN. QUADRANGLE

by
Roger E. Thomas and Alfred R. Taylor

U.S. Geological Survey
OPEN FILE MAP 82-653 (A-13)

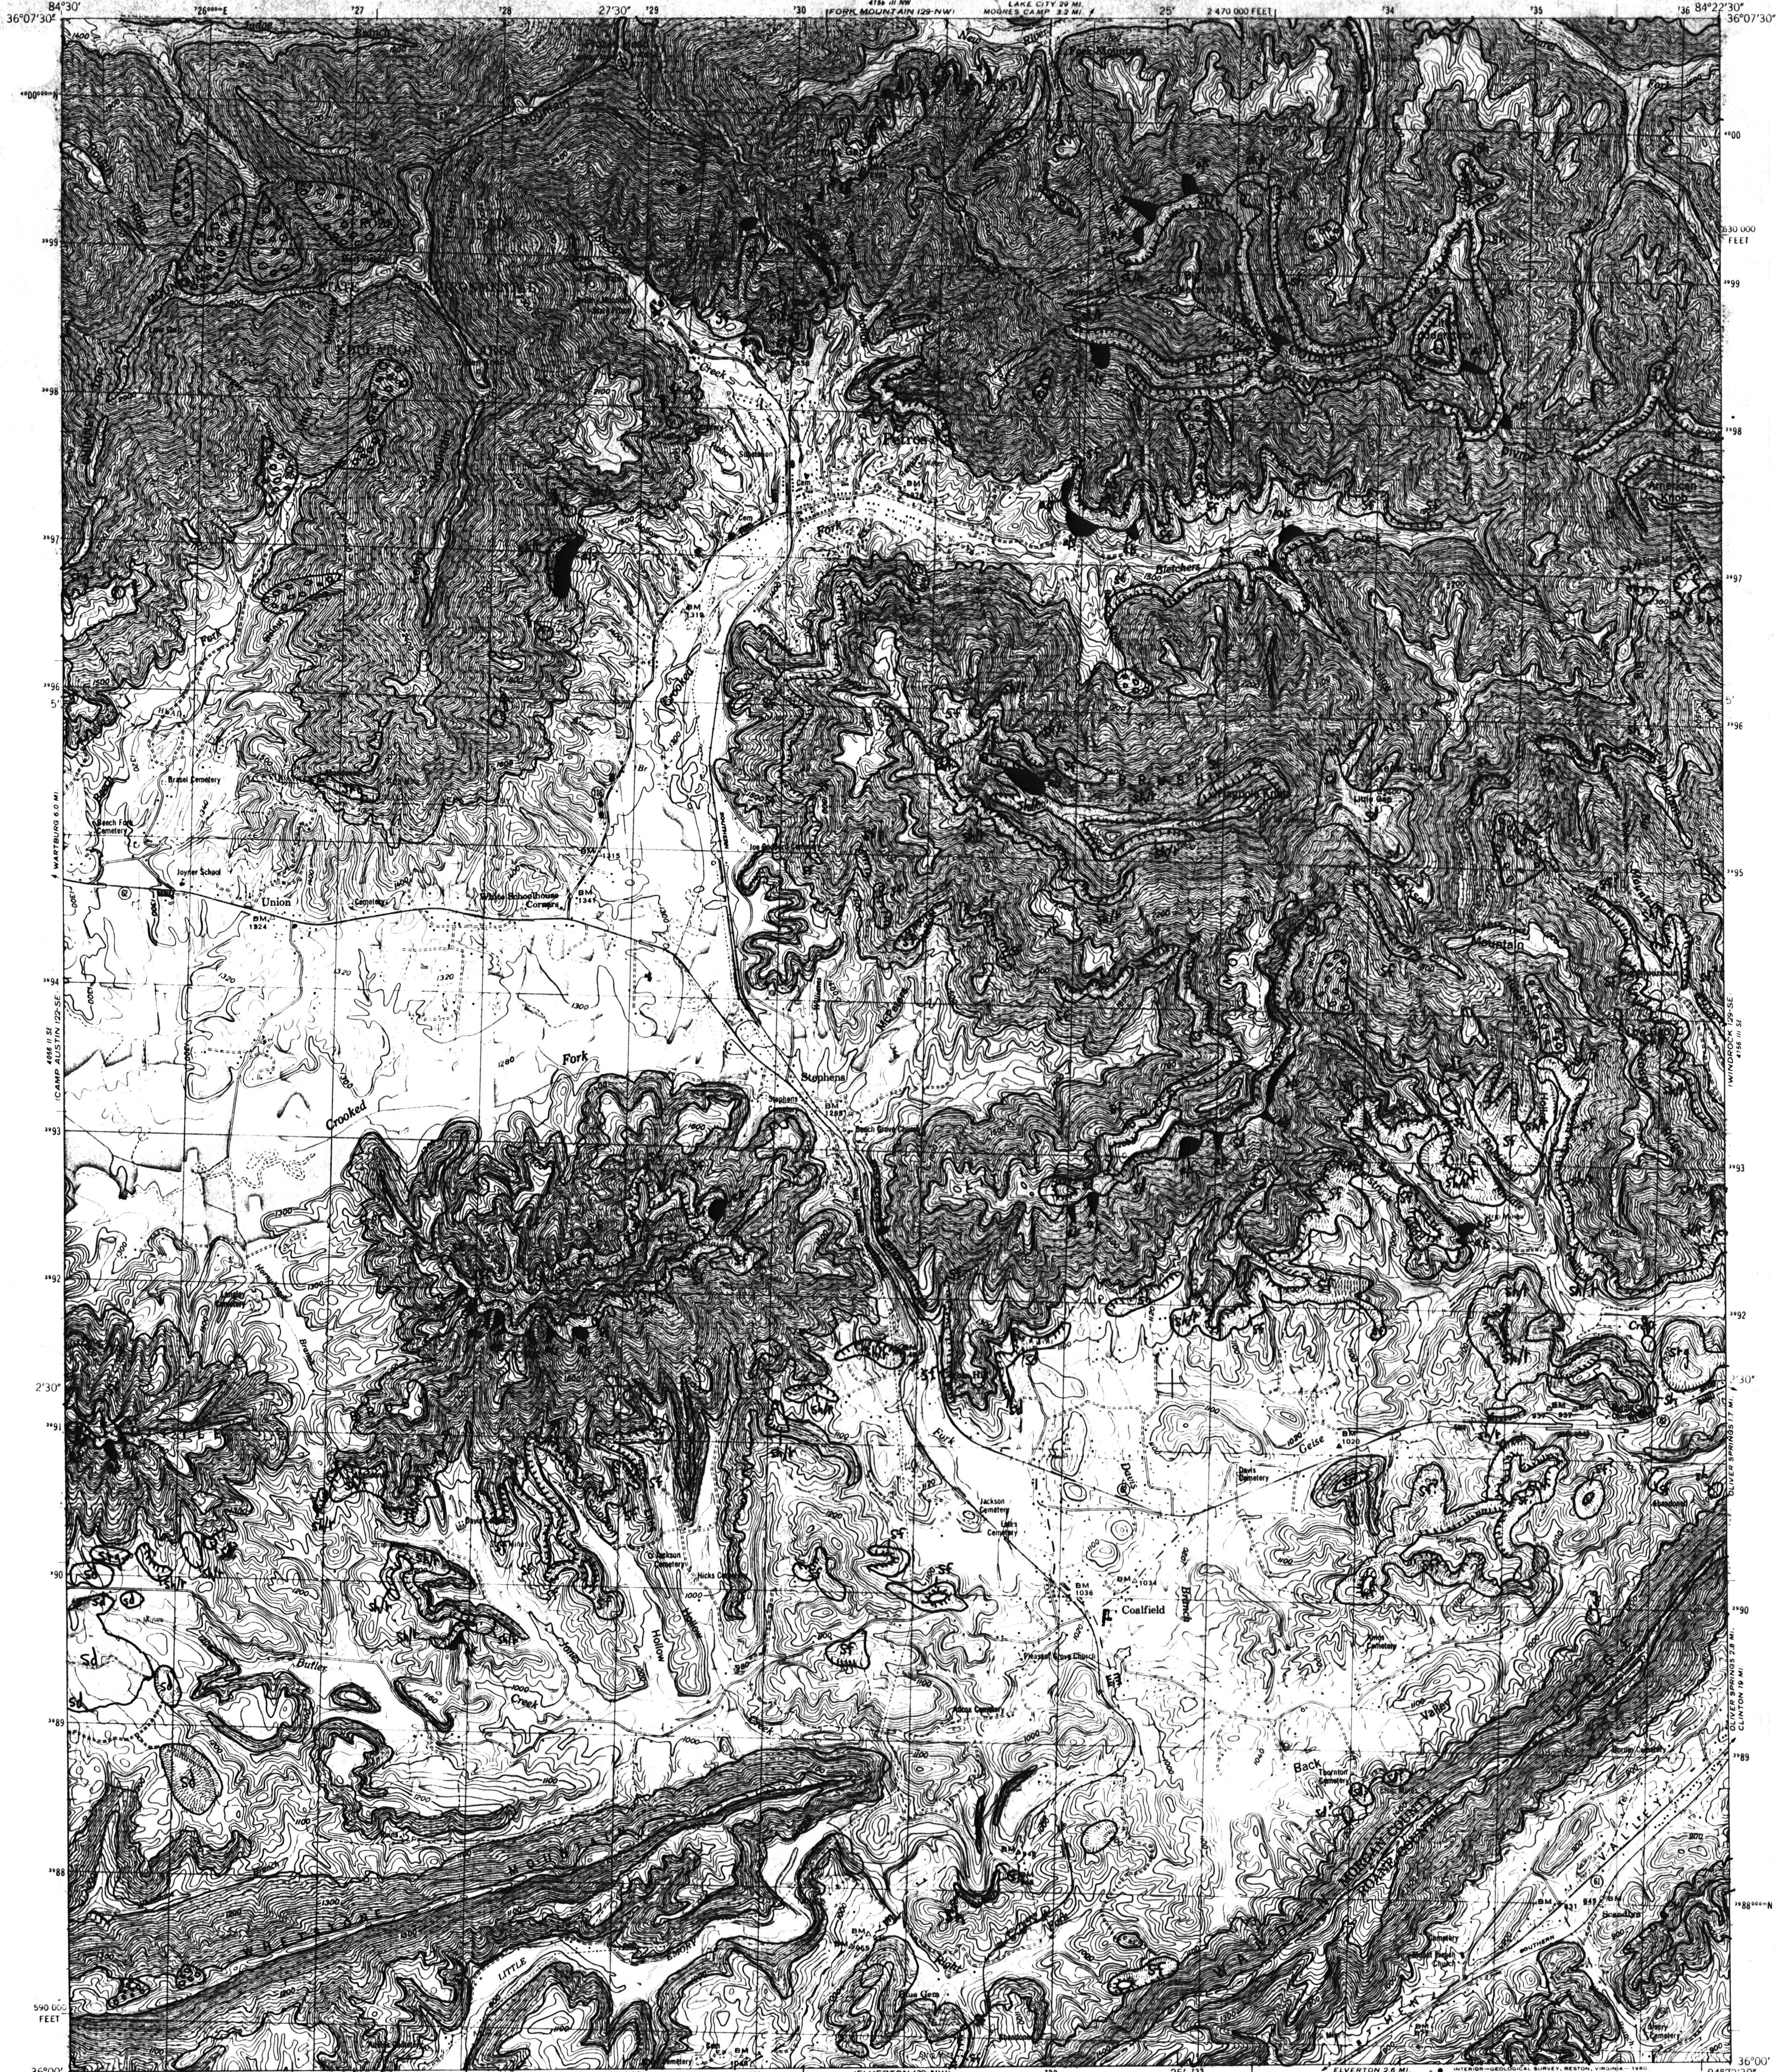
PETROS, TENN.
1952
PHOTO REVIS 1979

Landslides and related features interpreted
from aerial photographs:

ACTIVE OR RECENTLY ACTIVE LANDSLIDE
Complex landslide composed of earthflow, debris
slide, earth and rock slump. Identified from
historical records, and from scars, debris and
other field evidence. Ground extremely unstable;
sliding accelerated by excavation, loading and
changes in drainage conditions. May include
areas with several active slides too small to
be shown separately. Questioned where doubtful.

OLD LANDSLIDE
Area of extensive hummocky ground caused by
earthflow and earth and rock slump. Lacks
clear evidence of active sliding. Relatively
stable in natural, undisturbed state,
generally not affected by small structures properly
sited in areas away from the edge of the toe;
can be reactivated by extensive, rapid exca-
vation, loading, and changes in ground water and
surface water conditions. Area of old landslide
probably includes recent ones not identified
from field evidence or otherwise documented.
Upslope boundary of landslide generally defined
by modified scarp, but downslope (toe) may be
gradational and not well defined. Questioned
where doubtful.

COMBINATION LANDSLIDE
Area of recent and old slides in which
individual slides are not identified.

COLLUVIAL SLOPE
Valley wall along major streams with slope as
steep as 40° (85%); stony, clayey silt soil up
to 50 ft. (15 m) thick; commonly buttressed by
a terrace or bench at the toe of the slope; very
susceptible to sliding by cutting of toe area,
removal of terrace or bench, and overloading;
slide commonly activated without apparent cause.

**AREAS SUSCEPTIBLE TO DEBRIS FLOWS AND DEBRIS
AVALANCHES**
Primarily shallow, narrow ravines and chutes with
accumulation of stony colluvium generally 10 ft.
(3 m) or less in thickness; susceptible to rapid
movement during intense rainfall. Most ravines
and chutes designated show evidence of former
debris flows and avalanches.

AREAS SUSCEPTIBLE TO ROCKFALL
Steep, locally vertical, natural and man-made
slopes and cliffs, 15 ft. (4.5 m) or more high;
formed dominantly of sandstone, limestone, sandy
shale, mudstone and claystone. Interbedded mud-
stone, claystone and shale weather rapidly leaving
sandstone and limestone rock faces unsupported.

SOIL AND ROCK SUSCEPTIBLE TO LANDSLIDING
Soil and rock similar to that involved in land-
slides elsewhere in map area; primarily areas
underlain by claystone, mudstone and shale
associated with other rock types. Rock weathers
rapidly on exposure forming clayey soil highly
susceptible to sliding. Includes coves (U-shaped,
shallow valleys) containing thick layers of clayey
soil that are very susceptible to sliding where
excavation breaks continuity of slope and where
overloaded by artificial fill.
